# National Transportation Safety Board Aviation Accident Preliminary Report

<b>Location:</b>	Beaufort, NC	<b>Accident Number:</b>	ERA22LA120
<b>Date &amp; Time:</b>	February 13, 2022, 14:02 Local	<b>Registration:</b>	N79NX
<b>Aircraft:</b>	PILATUS AIRCRAFT LTD PC-12/47E	<b>Injuries:</b>	8 Fatal
<b>Flight Conducted Under:</b>	Part 91: General aviation - Personal

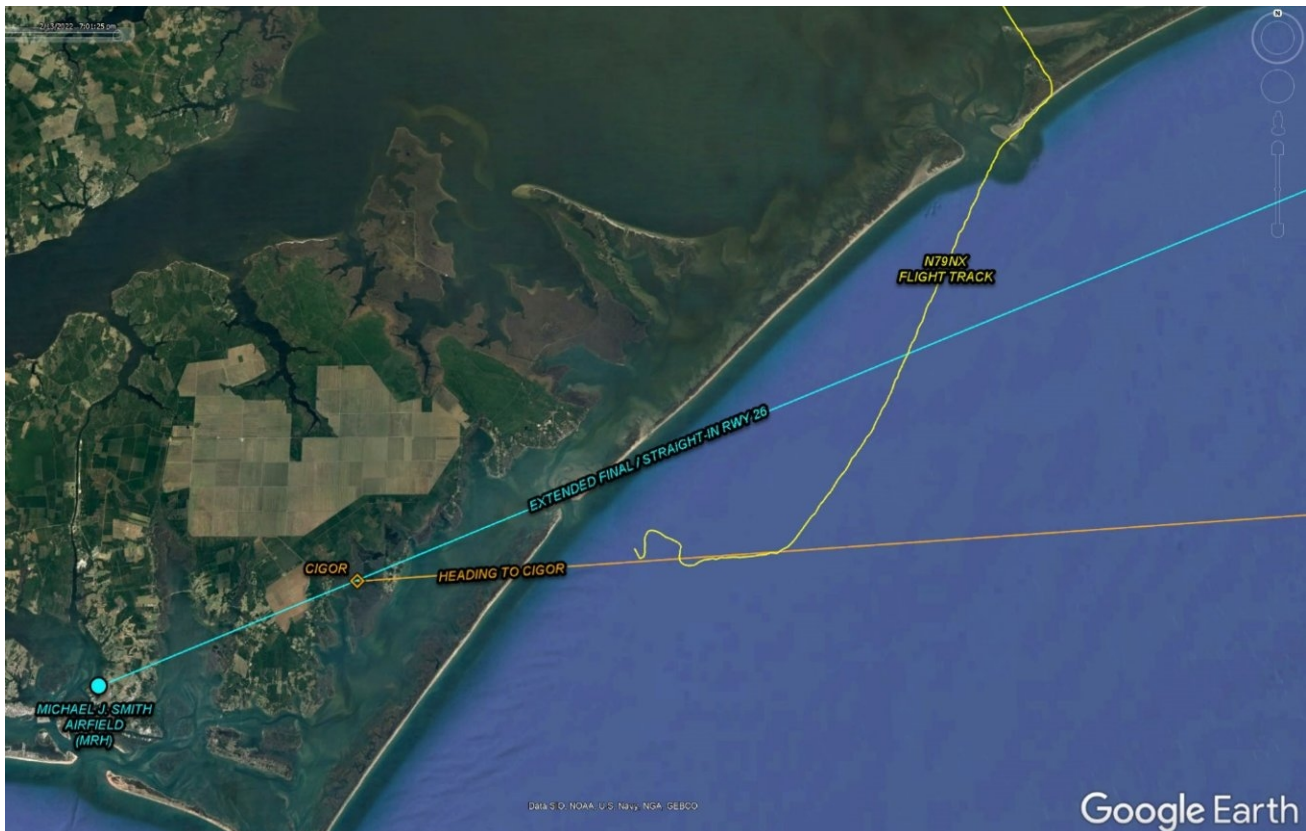
At 1401, the controller called the airplane and asked what altitude it was at because the airplane was at 4,700 ft msl and climbing quickly. There was no response. Radar contact was lost with the airplane at 1402 and an ALNOT was issued at 1429. Throughout the communication with air traffic control, there were no distress calls or a declaration of emergency from the airplane.

*Figure 1. Airplane flight track (yellow) overlaid with the heading to the initial approach fix (orange) and the destination extended runway centerline (blue).*
